P' ) 6/82		INVENTO		National Park Service Pacific Northwest Region Cultural Resources Division	Westin Buil 2001 Sixth Seattle Wa		1920 n 98121
2 NAME(S) OF STRUCTURE  Shriner Peak Fire Lo	(CARD 2 of 2)	5 ORIGINAL USE  Fire Lookout	7. CLASS	SIFICATION		9. RATII	ING
Shriner Peak 0-052 (	(formerly HX-1)	6 PRESENT USE Fire Lookout and Backcountry Assistance	8. UTM	ZONE EASTING NO	ORTHING	193	
4 city/vicinity Ohanapecosh	COUNTY Lewis	STATE Washington	SCALE	1:24 1:62.5 OTHER:	QUAD NAME		
NPS / Mount Rainier BESCRIPTION AND BACKGROUND HIS BESCRIPTION AND	STORY INCLUDING CONSTRUCTION DATE(S , ENGINEERS, ETC.	Woods-Star Route, Ashfo	LTERATION	S, EXTANT EQUIPMENT, AND			
Shriner Peak Lookout	undoubtedly saw a ore	eat deal of activity in .	July (	of 1934 when a large fi	re burned 63	O acres of	2

# National Register of Historic Places Continuation Sheet

REQUESTED ACTION: NOMINATION Shriner Peak Fire Lookout PROPERTY NAME: MULTIPLE Mt. Rainier National Park MPS NAME: STATE & COUNTY: WASHINGTON, Pierce DATE RECEIVED: 1/29/91 DATE OF PENDING LIST: 2/12/91 DATE OF 16TH DAY: 2/28/91 DATE OF 45TH DAY: 3/15/91 DATE OF WEEKLY LIST: REFERENCE NUMBER: 91000194 NOMINATOR: FEDERAL NPS REASONS FOR REVIEW

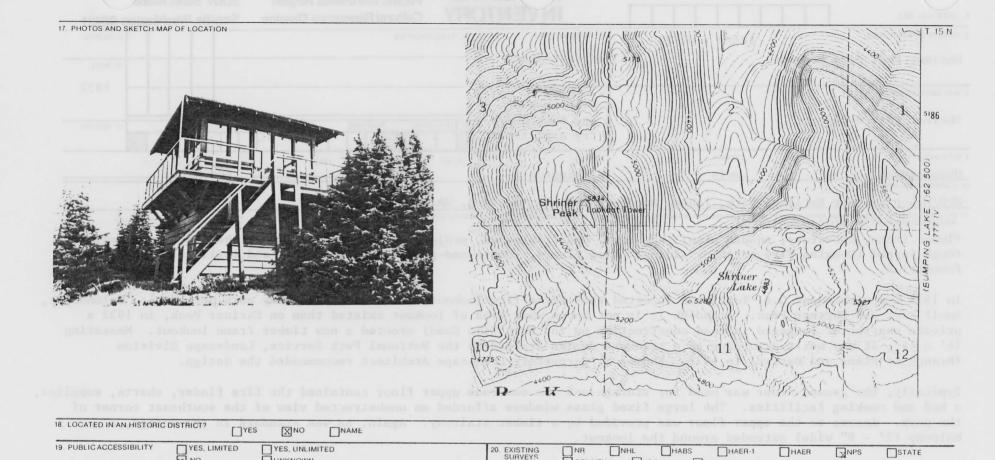
Timber frame, two-story, square plan; hip roof, cedar shingles, projecting eaves; wrap around balcony, fixed sashes, rough lapped (Douglas Fir) exterior siding; wood floors, tongue-and-groove interior walls and ceilings; concrete foundation.

Typically, the ground floor was used for storage and the one-room upper floor contained the fire finder, charts, supplies, a bed and cooking facilities. The large fixed glass windows afforded an unobstructed view of the southeast corner of the park. Access to the upper floor was provided by a timber stairway. Again, as was standard in the design, a balcony (2' - 8" wide) extended around the lookout.
