**National Register of Historic Places  
Inventory—Nomination Form**

NAME: Green Mountain Lookout

CLASSIFICATION/CATEGORY: Building

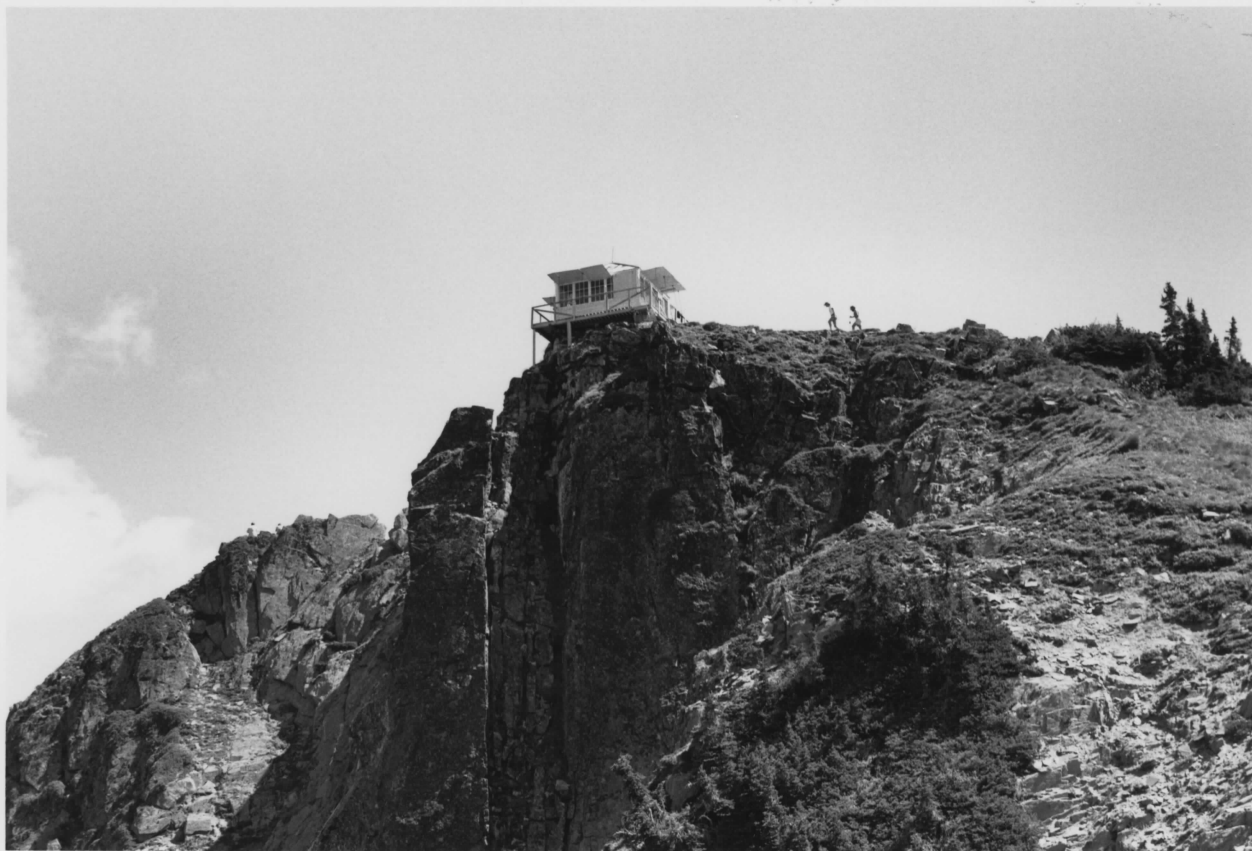
6 of 25

View east of west elevation

This one-story, single room, 14 x 14 feet cabin is wood-frame construction built according to standard Forest Service Lookout House plans from c. 1930. The floor framing system is supported on and anchored to a pinnacle of rock outcroppings and mortared rock. A guy anchorage system is also utilized to provide additional stability against severe wind and snow loads. The standard cabin is surrounded by a reconstructed catwalk and the pyramidal roof is covered entirely by cedar shingles. The roof and some walls were apparently reconstructed "in kind" due to severe storm damage c. 1950. Exterior walls are composed of nine-light inward hinged sash with dropped siding below. Temporary plywood shutters which utilize original hinge and steel rod support hardware are currently in use, although deteriorated original shutters remain on the site. The original panel door with nine-lights above remains in place. The greatest alteration to the original lookout is the current catwalk and supports which were reconstructed (c. 1984) as an emergency measure due to severe winter storm damage. Although similar, the reconstruction was not based on original architectural details. A "user group" is currently being organized with the intention of complete reconstruction of the shutters and catwalk according to original architectural details. Intact interior finishes include dropped siding at walls and beaded board on ceiling and standard 1 x 4 fir flooring. The interior also exhibits typical simply constructed furnishings which include standard firefinder and stand, table, built-in cabinets and shelves, lightning stool and a manufactured cast iron stove.

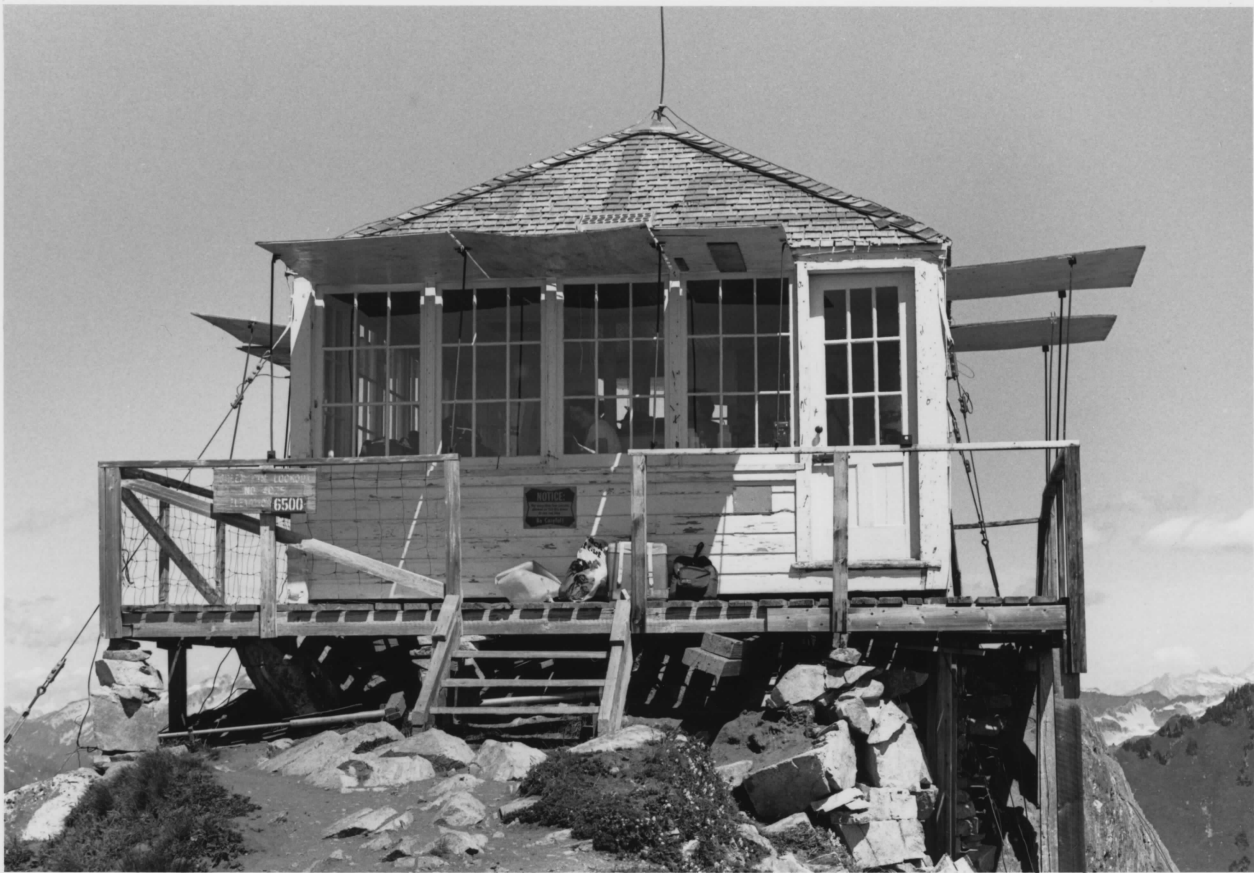
7 of 25

South elevation
